Report No. 710/393
Watertown Arsenal
Restricted

October 29, 1941

Metallurgical Examination of Punchings from
Cast Turret of British A-12 Infantry Tank

The purpose of this investigation was to determine the metallurgical characteristics of these punchings blown from the cast turret of the British A-12 Infantry Tank by 75 mm. R61 A.R. shell.

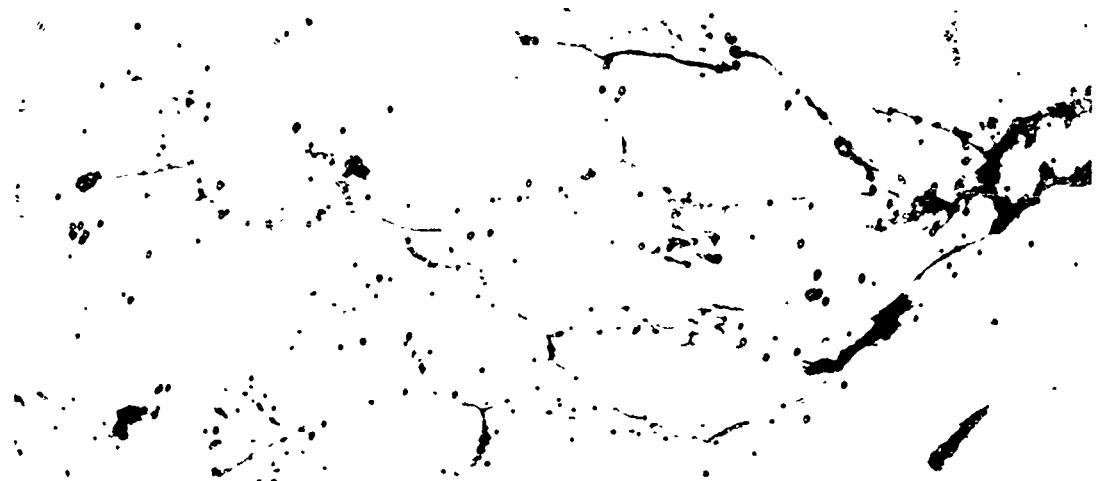
a. Magnified 100 Diameters

It is believed that the nonmetallic substance visible around the grains in the unetched section has been opened up by the hot acid etch, which also reveals that this condition is more general than expected from the examination of the unetched surfaces.

- (a) No. 1-1 - Films around grain boundaries found in isolated region in microspecimen. The hot acid etch shows this condition to be more widespread than expected from an examination of the polished unetched surfaces.

It is believed that the coarse fracture found on the punchings is due to failure extending along defective regions like the above. Although only isolated regions of this type were found in the polished specimens, the hot acid etch revealed a more general occurrence of hairline cracks, and a coarse, open dendritic structure, associated with shrinkage porosity.

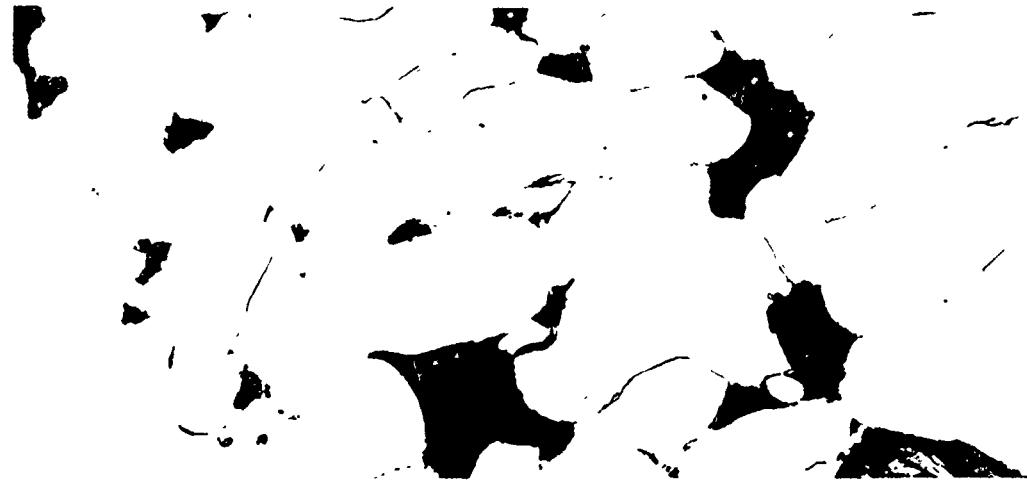
b. Magnified 100 Diameters

The general inclusion rating of the turret is about average for cast armor plate, with some nonmetallics segregated in the interdendritic fillings. Throughout the sample, however, are small areas in which nonmetallic material surrounds the grain boundaries. There are also segregations of nonmetallics in some areas that are more pronounced than in the average case. Areas containing porosity are found which have grain boundary cracks adjacent to the porosity.

- (b) No. 1-2 - Oxides and oxide films around grains found in a porous region about $1/8'' \times 1/4''$ in area on specimen.

- (c) No. 1-2 - Porosity and grain boundary cracks found in a porous area about $1/8'' \times 1/4''$ in extent.

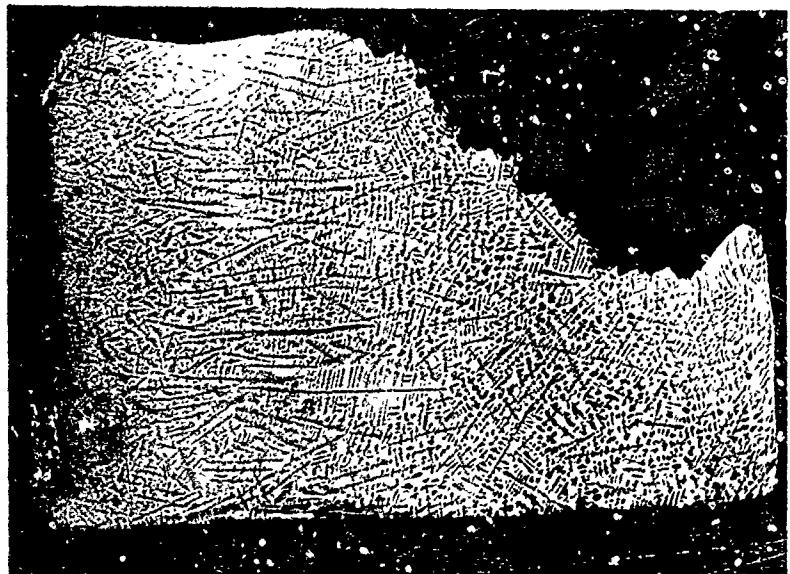
a.

followed the dendritic pattern. (See Figure 11a.) Figure 11b shows macrostructure of some punching after Watertown Arsenal heat treatment.

- (a) Macrostructure of specimen No. 2-1 which had a coarse fracture. The fracture follows the outline of the interdendritic filling material in which the impurities and oxide films are segregated.

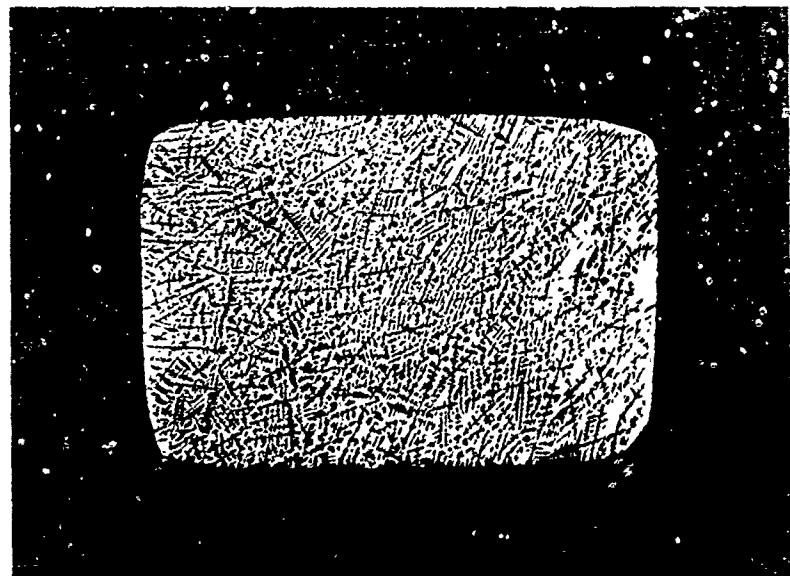
b.

- (b) Macrostructure of specimen No. 3 after the homogenizing heat treatment:

No appreciable change in the macrostructure was produced by the treatment.

2000°F - 10 hours - air cool
1650°F - 3 hours - air cool
1150°F - 4 hours - air cool
